SR 302 Victor Area Corridor Study MP 0 to MP 7.7

June 2023

Parametrix

SR 302 Victor Area Corridor Study

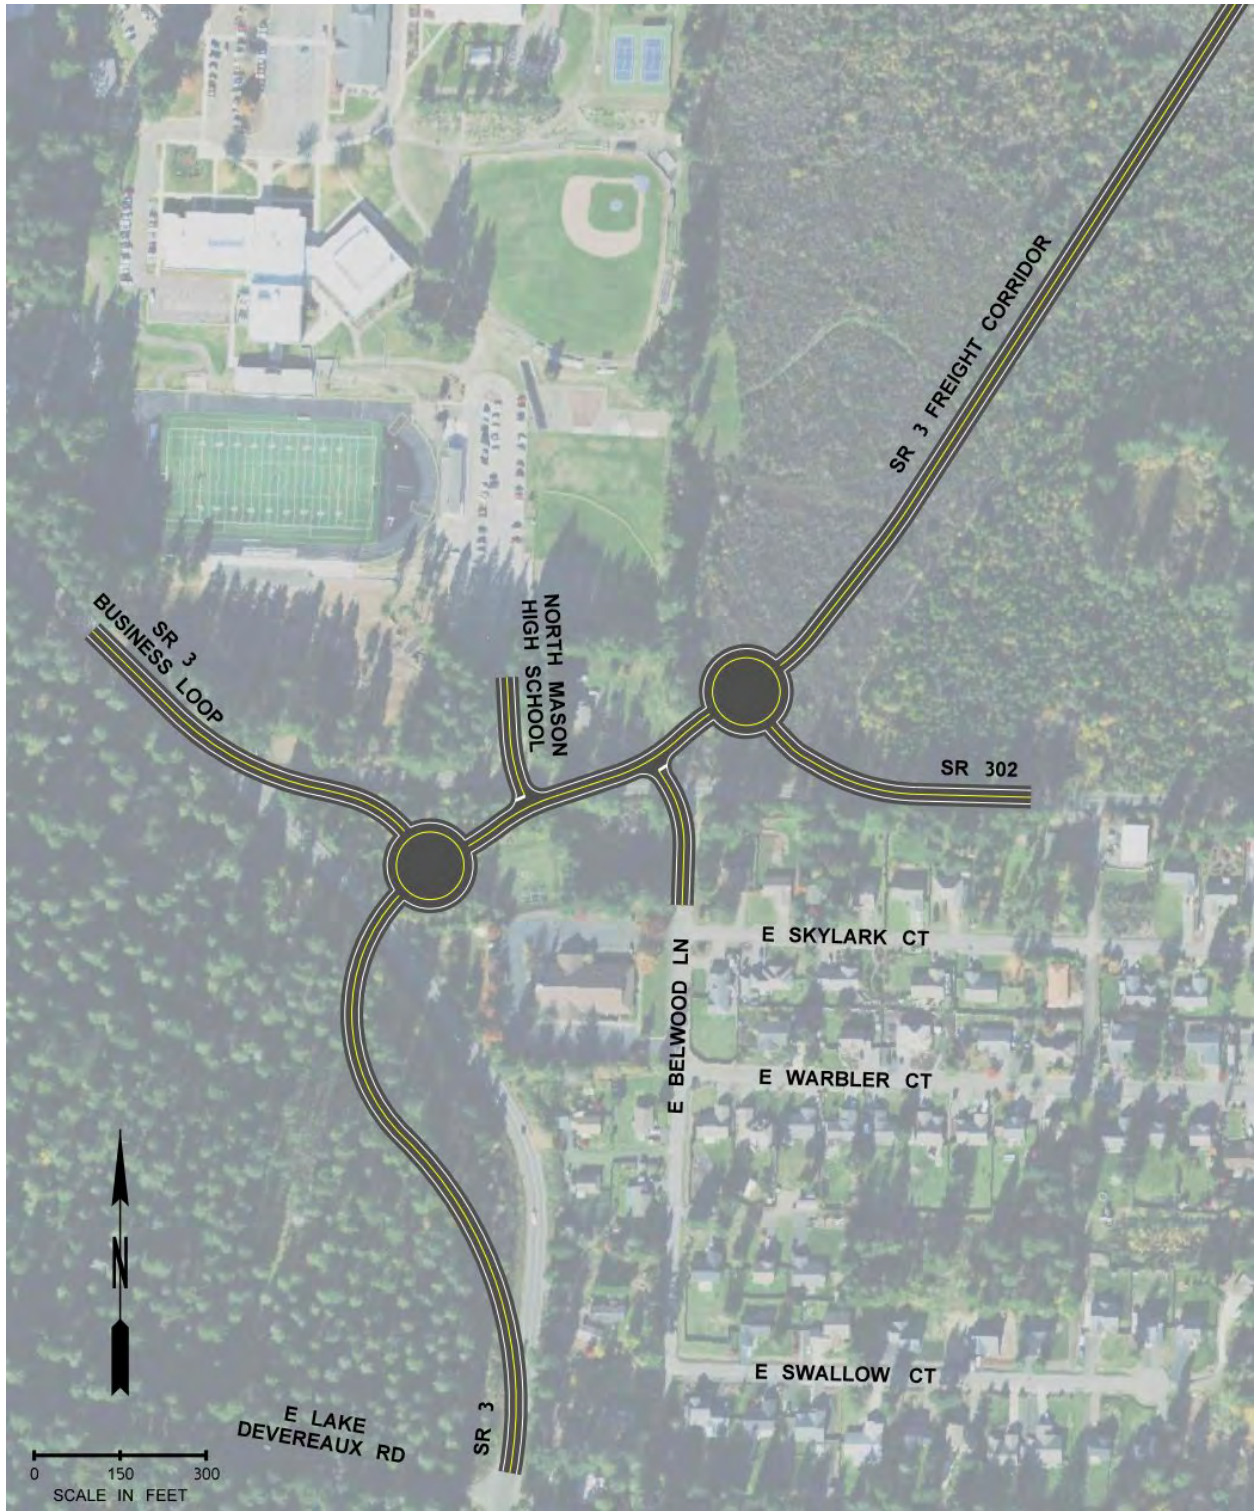
Figure 6. SR 3 Freight Corridor Study Improvements

As mentioned in Section 1.4 improvements from the SR 3 Freight Corridor Planning Study (WSDOT 2020) are expected to be completed by Year 2030. The recommended south-end connection for the new SR 3 freight corridor includes two single-lane roundabouts at the SR 3 Business Loop/SR 3 Freight Corridor and SR 3 Freight Corridor/SR 302 intersections, as shown in Figure 6. No other changes to the SR 302 corridor within the study area are expected for the Year 2030 Future No Build Condition.

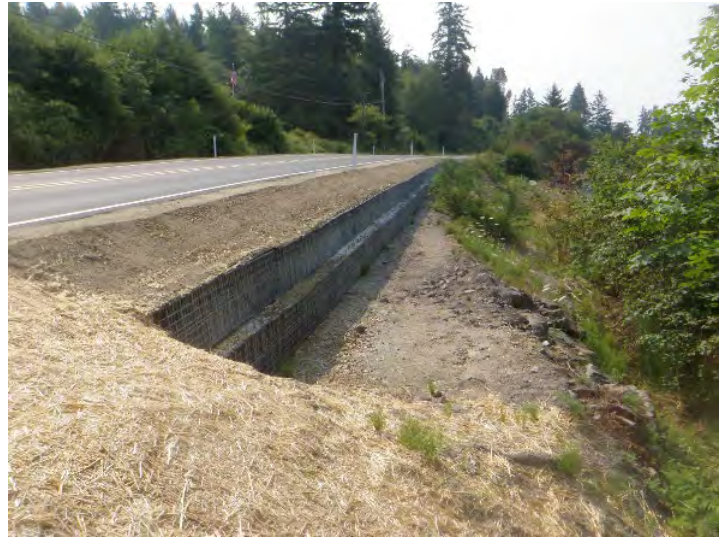
Figure 14. Lightweight Cellular Concrete – Example

- **Short-term/lower cost partial mitigation:** the geotechnical recommendation is lightweight cellular concrete fill with drainage improvements. The intention is to reduce groundwater levels to improve the stability of the roadway slope. For transportation, the recommendation is to improve communication during roadway closures of SR 302 for both planned construction and potential emergencies.

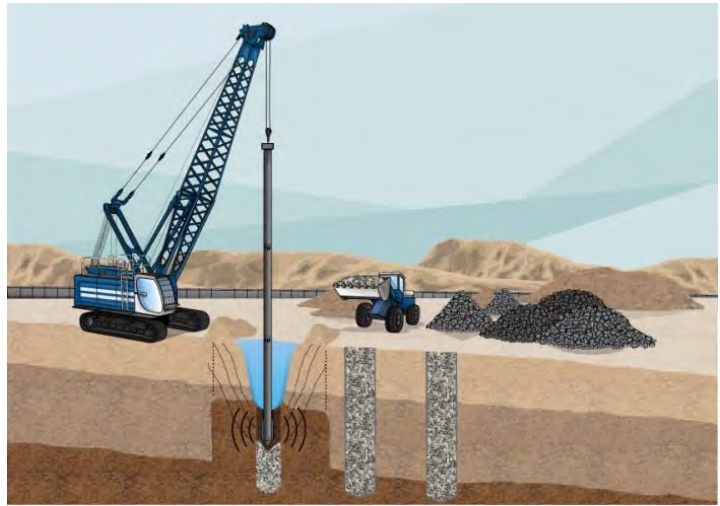
Figure 15. Aggregate Shafts – Example

- **Mid-term/partial mitigation:** the geotechnical recommendation is aggregate shafts with drainage improvements. The intention is to replace weak soils below the roadway and improve the stability of the roadway slope by improving the strength parameters of the existing soils.

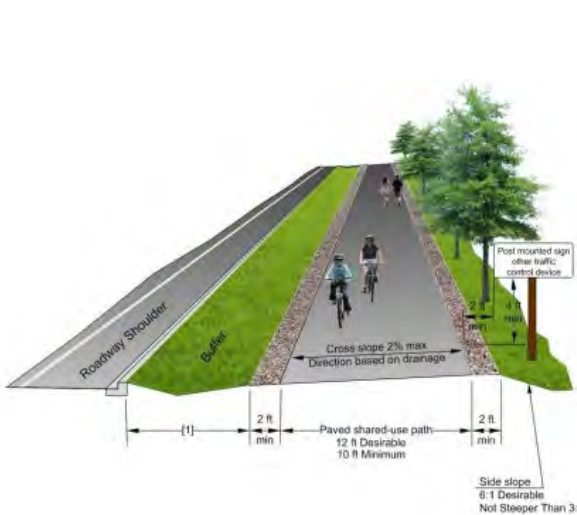
Figure 18. Shared-Use Path (≤ 35 mph)

For Strategy #2 Shared-Use Path, two examples of two-way shared-use paths, per WSDOT Design Manual guidance (WSDOT 2022d), are shown in Figure 18 and Figure 19. Figure 18 should be referenced for roadway speeds of 35 mph and lower (Segment 1), and Figure 19 should be referenced for roadway speeds greater than 35 mph.

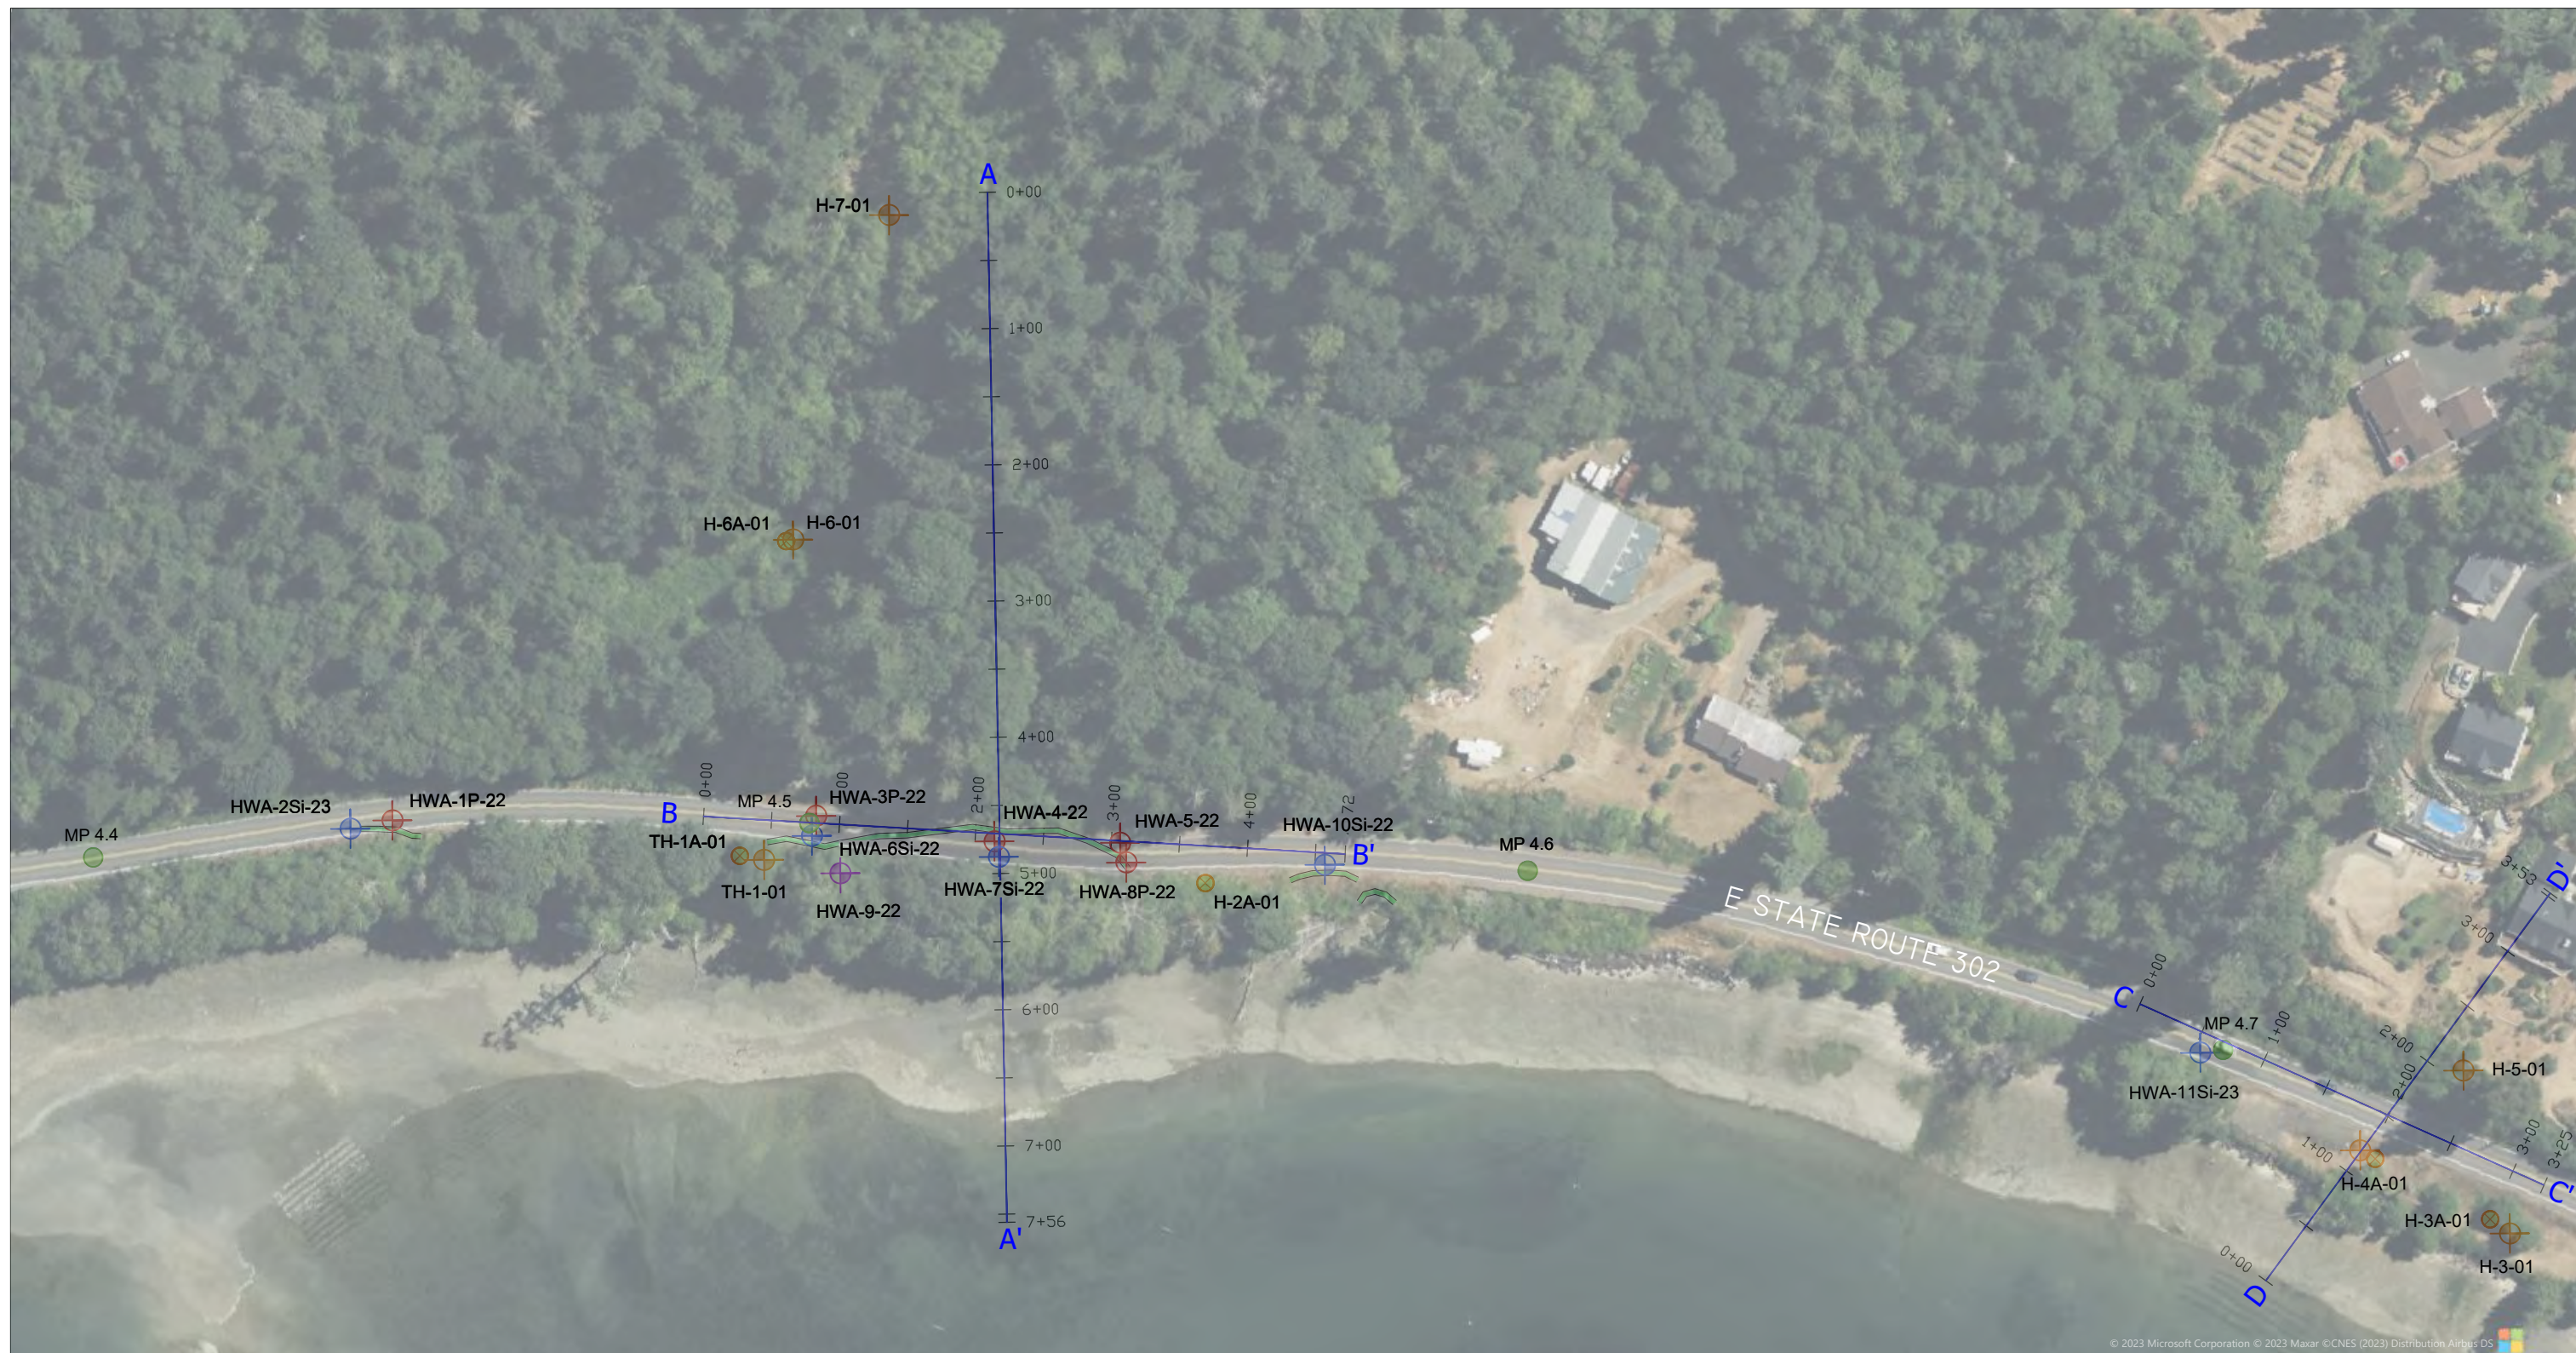
EXPLORATION LEGEND

- HWA-1P-22 50'-80' BORING DESIGNATION, DEPTH, AND APPROXIMATE LOCATION
- HWA-9-22 20'-30' LIMITED ACCESS BORING DESIGNATION, DEPTH, AND APPROXIMATE LOCATION
- HWA-2Si-22 100' BORING WITH INCLINOMETER DESIGNATION, DEPTH, AND APPROXIMATE LOCATION
- TH-1A-01 EXISTING WDSOT 1-INCH MONITORING WELL, DESIGNATION AND APPROXIMATE LOCATION (2001)
- TH-1-01 EXISTING WDSOT INCLINOMETER, DESIGNATION AND APPROXIMATE LOCATION (2001)
