Antifouling Paints in Washington State: Third Report to the Legislature

Hazardous Waste & Toxics Reduction Program

Washington State Department of Ecology

June 2024 | Publication 24-04-034

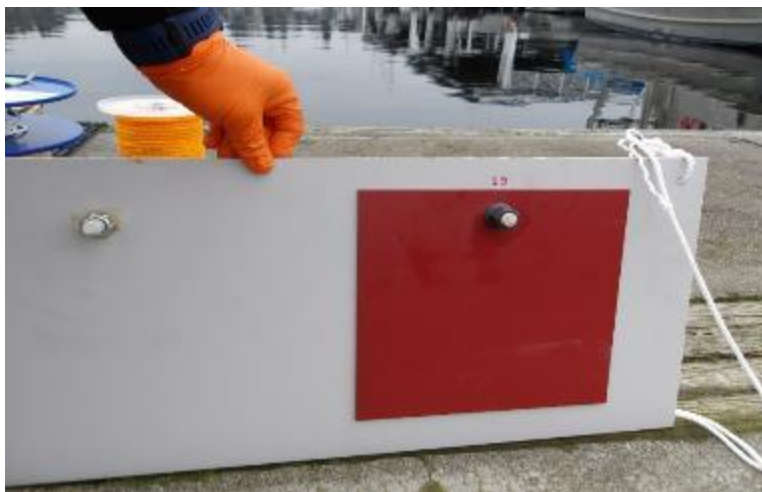
Figure 2: A panel mounted on the rack before submerging into lake water in Seattle, WA.

The paints were applied on each panel by following the manufacturers' instructions and were fully cured to no tacky state. The panels were mounted on racks using the non-conductive fiberglass studs and hex nuts to avoid corrosion. The racks were then submerged in water, only

after the minimum period required before flooding was achieved and no later than the maximum time limit after the paint application. Prior to flooding, the thickness of the paint system was measured for each panel. Racks were submerged between 1.5 to 3.5 feet deep below water. Figure 2 shows the rack with a mounted panel (PIN 19, SeaVoyage®) before submerging into water.

Initially, the ropes used to tie the racks with the piers or rafts were polypropylene (yellow ropes in the Figure 2). However, they degraded quickly under the sunlight, and were replaced by ¼-inch thick Nylon 3-strand rope after a few months of monitoring, as shown in Figure 2. At the Seattle Yacht Club, additional cleats were also mounted to support the racks.

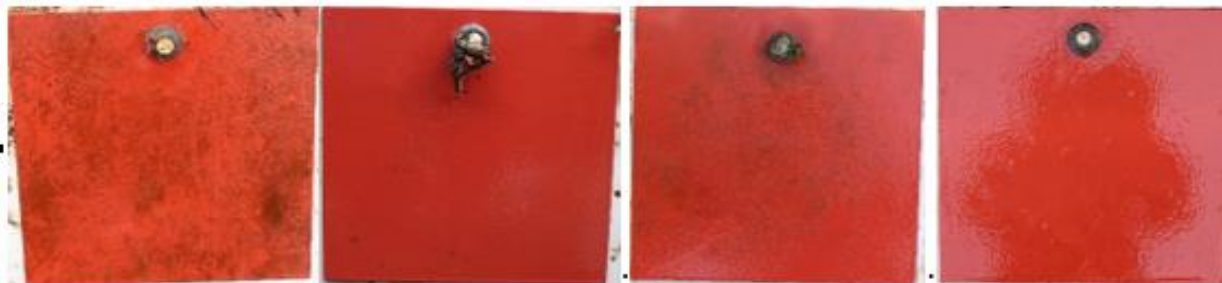
Figure 3: SeaVoyage® (control), PIN 19 – from Port Orchard, Gig Harbor, Anacortes, and Seattle – January 2024 (left to right).

At the end of the performance testing, each panel was gently washed with tap water except at Anacortes, where ocean water was used in a pitcher. We recorded panel conditions before and after the gentle washing, in the form of photos and videos. Figures 3 to 21 show the panels' conditions from January 2024 in all four test locations, after the gentle washing.

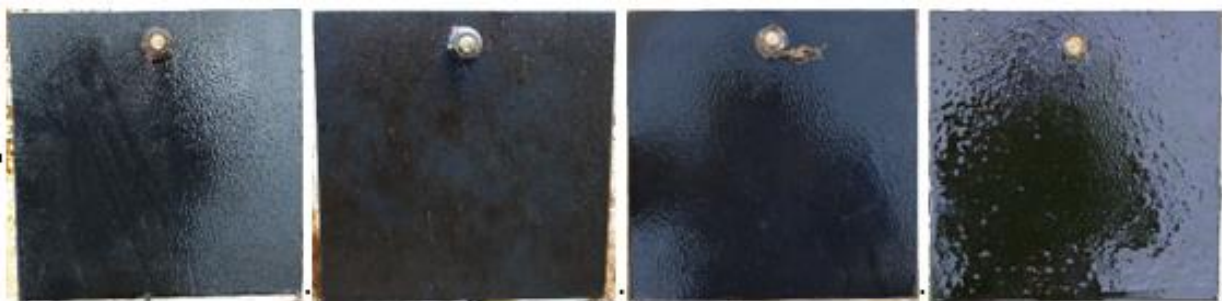
Figure 4: Hydrocoat® ECO, PIN 1 – from Port Orchard, Gig Harbor, Anacortes, and Seattle – January 2024 (left to right).

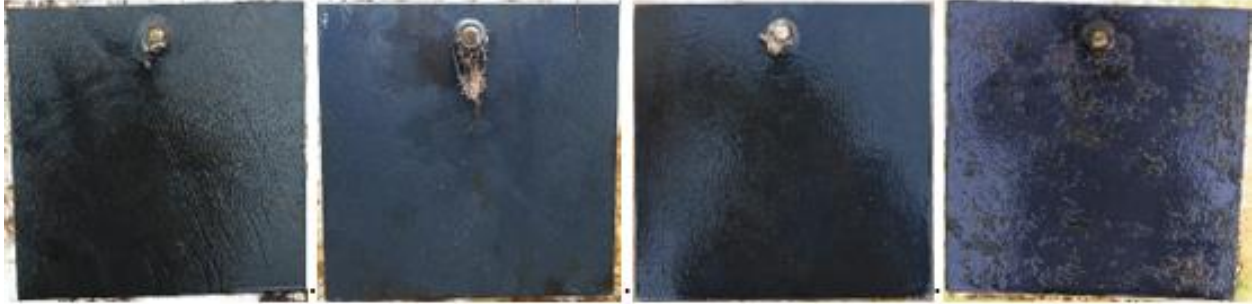
Figure 5: ECO-HRT®, PIN 2 – from Port Orchard, Gig Harbor, Anacortes, and Seattle – January 2024 (left to right).

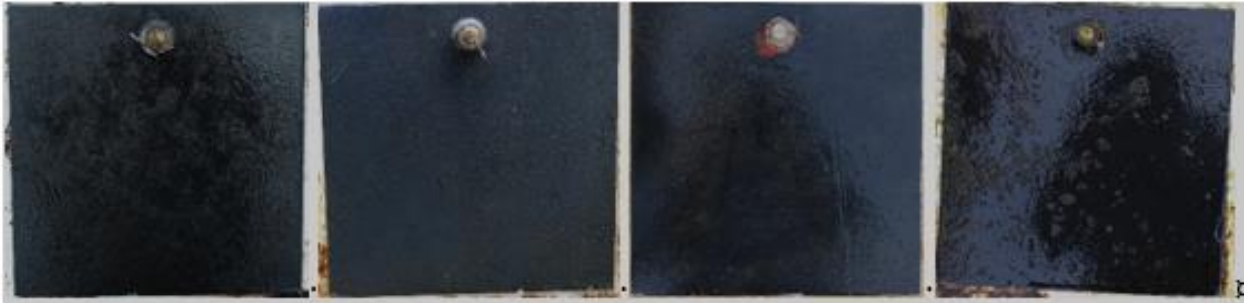
Figure 6: Micron CF, PIN 3– from Port Orchard, Gig Harbor, Anacortes, and Seattle – January 2024 (left to right).

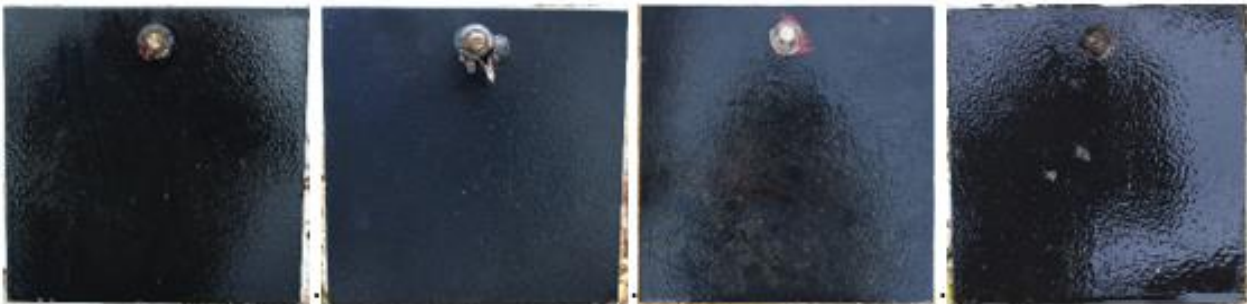
Figure 7: Pacifica Plus, PIN 4 – from Port Orchard, Gig Harbor, Anacortes, and Seattle – January 2024 (left to right).

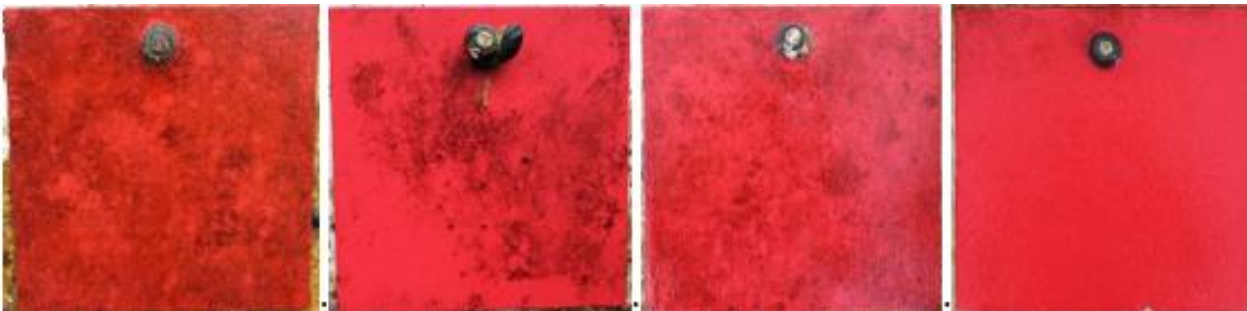
Figure 8: Smart Solution, PIN 5 – from Port Orchard, Gig Harbor, Anacortes, and Seattle – January 2024 (left to right).

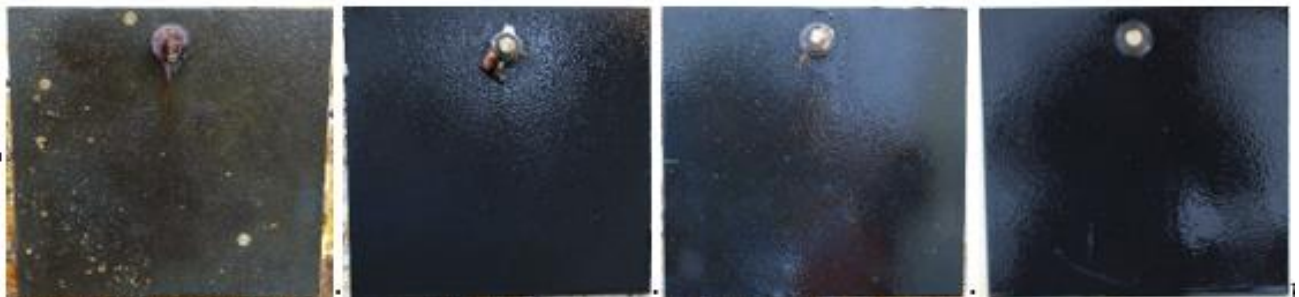
Figure 11: SN-1, PIN 8 – from Port Orchard, Gig Harbor, Anacortes, and Seattle – January 2024 (left to right).

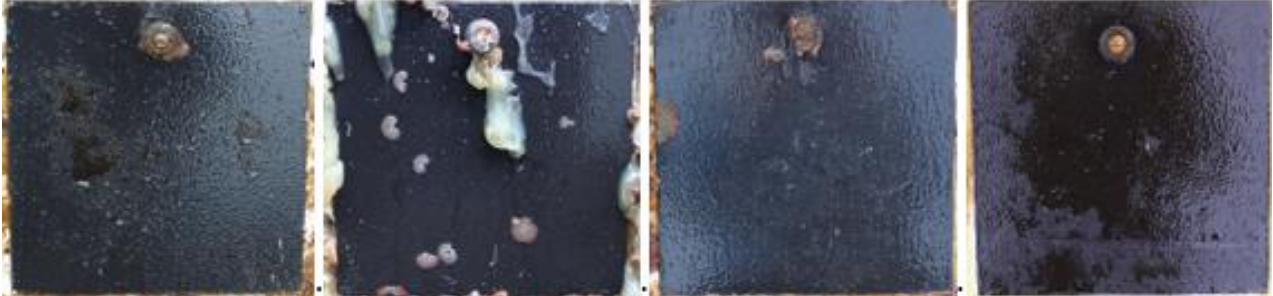
Figure 13: InterSleek® 1100 SR, PIN 10 – from Port Orchard, Gig Harbor, Anacortes, and Seattle – January 2024 (left to right).

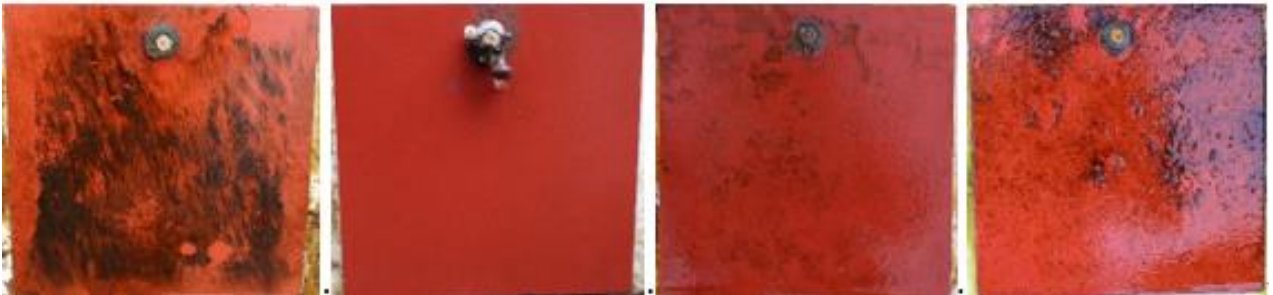
Figure 15: CUKOTE, PIN 12 – from Port Orchard, Gig Harbor, Anacortes, and Seattle – January 2024 (left to right).

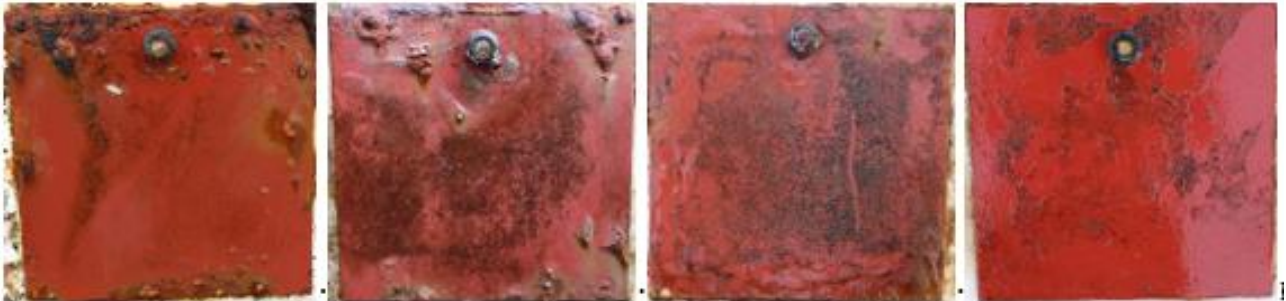
Figure 18: PCA Gold, PIN 15 -- from Port Orchard, Gig Harbor, Anacortes, and Seattle – January 2024 (left to right).

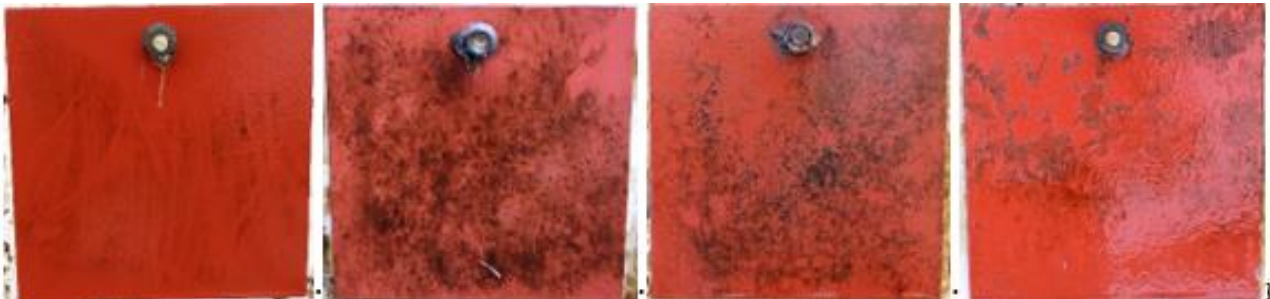
Figure 19: Micron® CSC*, PIN 16 -- from Port Orchard, Gig Harbor, Anacortes, and Seattle – January 2024 (left to right).

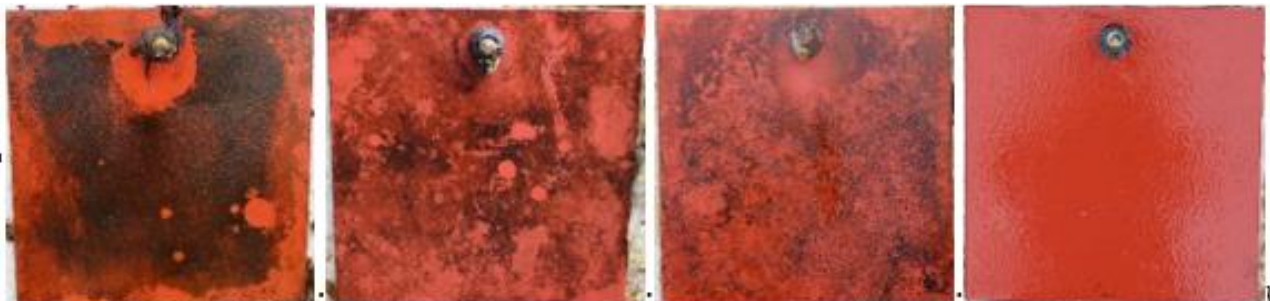
Figure 20: Fiberglass Bottomkote® NT, PIN 17 – from Port Orchard, Gig Harbor, Anacortes, and Seattle – January 2024 (left to right).

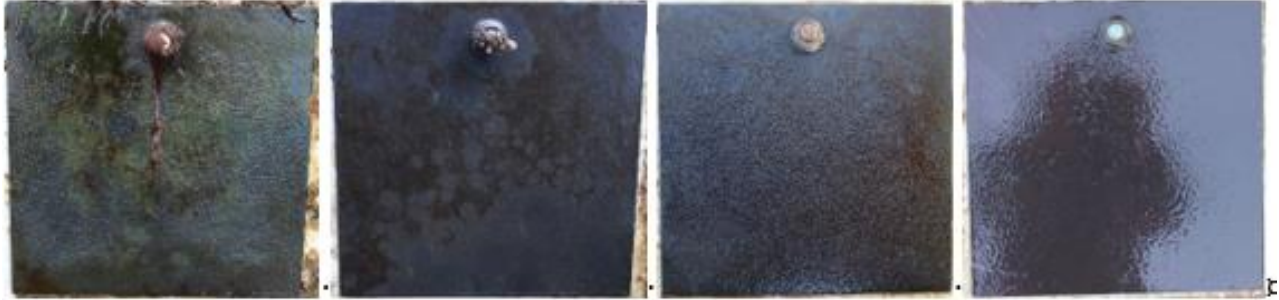
Figure 21: Interspeed 640, PIN 18 -- from Port Orchard, Gig Harbor, Anacortes, and Seattle – January 2024 (left to right).
