**Performance of Steel Slag Aggregates
in Hot-Mix Asphalt Pavement**

*A Report to the State Legislature
In Response to ESSB 6106, Section 307 (14)*

Washington State Department of Transportation

December 2018

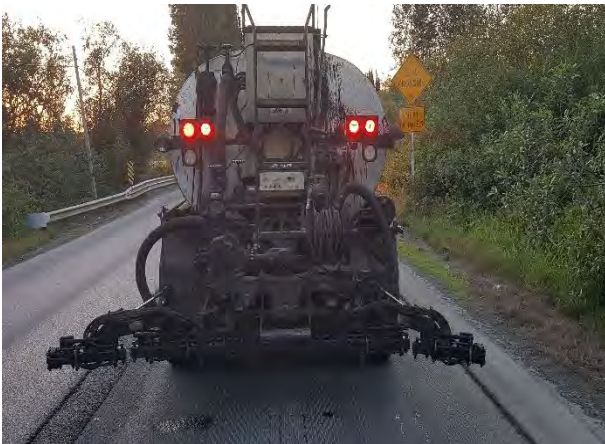
Figure 2. Bearcat distributor on milled surface.

Paving of the conventional mix took place between June 29 and October 11, 2016. A site visit by the Pavement Office on June 29, 2016 observed the paving operation. The weather was clear with ambient air temperature of 75°F and surface temperatures near 73°F although closer to 80°F nearest the paver during paving. The temperature of the mix at the screed was consistently around 290°F. The asphalt tack, which provides adhesion between the existing pavement and the new pavement, was delivered in a Bearcat distributor truck that applied CSS-1 at a rate of 0.05 gal/yd² at a temperature of 150°F. Dump trucks with pup trailers or flow boys were used to transport the HMA from the plant to the jobsite located approximately 20 minutes away (about 15 miles). The trucks dumped into a Roadtec Shuttle Buggy SB2500B Material Transfer Vehicle (MTV) for remixing prior to the transfer into the paver. A BG1055E Barber Greene paver equipped with a paver hopper (to hold additional material) and a CAT AS3301C screed laid down the mat. The compaction equipment consisted of a HAMM HD 120 oscillation steel-wheel breakdown roller used in vibratory mode, a Sakai GW 750-2 pneumatic vibratory intermediate roller used in vibratory mode, and a Sakai SW850 steel-wheel vibratory finish roller operated in non-vibratory mode. Figure 2 through Figure 9 show the construction process for the conventional mix in the control section.

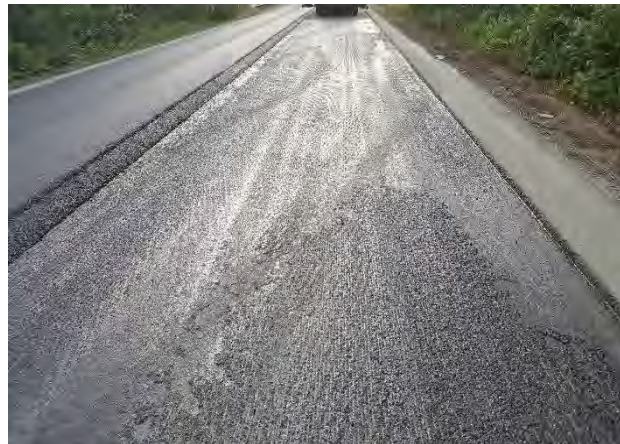
Figure 3. Milled surface with CSS-1 tack coat.

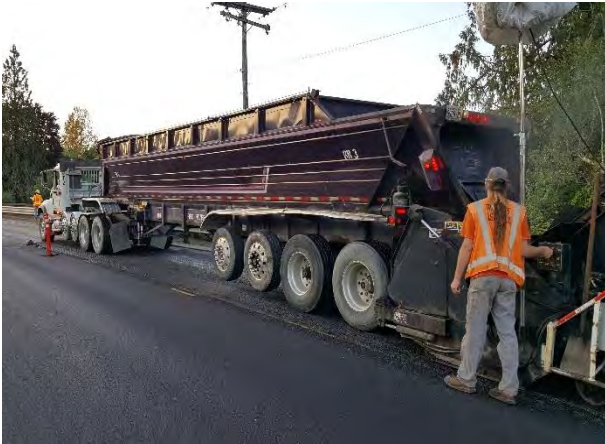
Figure 4. Flow Boy truck delivery to Shuttle Buggy MTV.

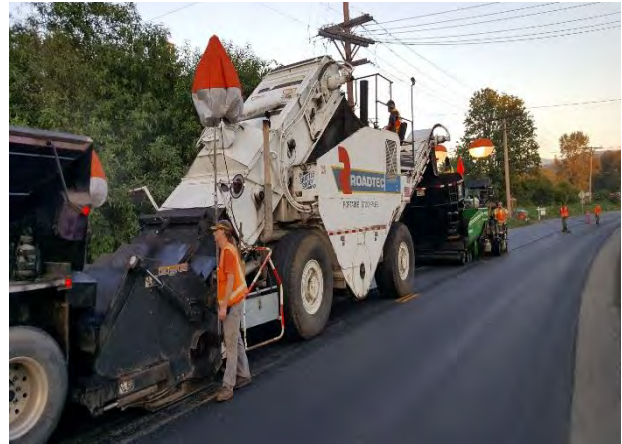
Figure 5. Shuttle Buggy MTV delivering HMA into hopper on the paving machine.

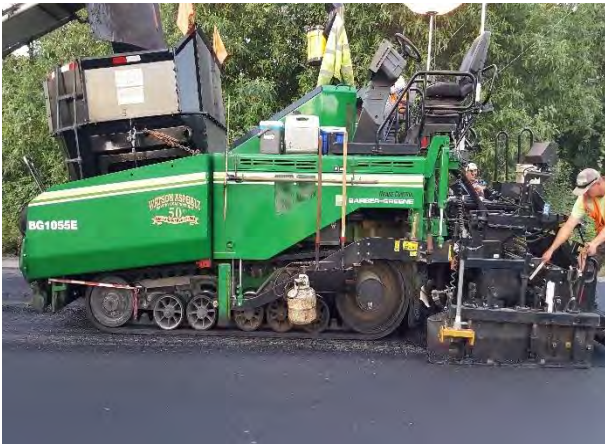
Figure 6. Barber Greene paver with storage hopper.

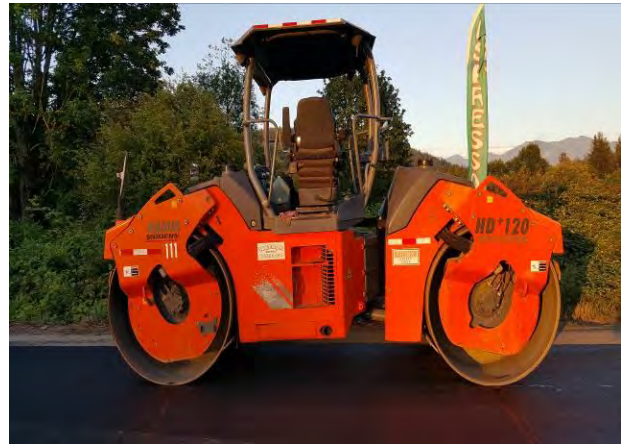
Figure 7. HAMM HD 120 steel wheel oscillatory breakdown roller.

Paving proceeded in the northbound direction beginning at MP 0.09. The breakdown roller was rolling from the hot side of the joint approximately four minutes behind the screed. The total time for the breakdown rolling was about seven minutes. The intermediate roller was approximately seven minutes behind the screed and took approximately eight minutes to compact the mat. The finish roller was 11 minutes behind the screed and took approximately 10 minutes to complete compaction.

The compaction equipment for the SSA mix was the same as that used on the conventional HMA mix; however, their order was different. Breakdown rolling was accomplished with the Sakai SW850 steel-wheel roller used in vibratory mode, intermediate rolling by the Sakai GW 750-2 pneumatic roller in vibratory mode, and finish rolling by the HAMM HD 120 oscillation steel-

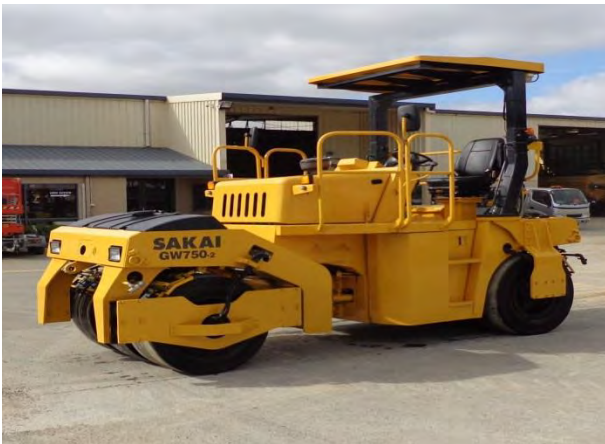
Figure 8. Sakai GW 750-2 pneumatic vibratory intermediate roller.

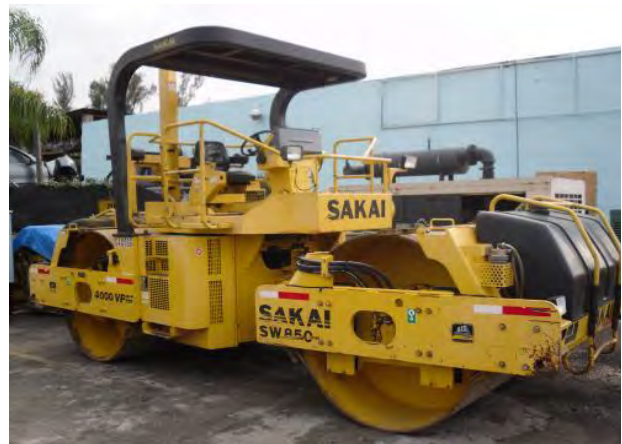
Figure 9. Sakai SW850 steel wheel vibratory finish roller.

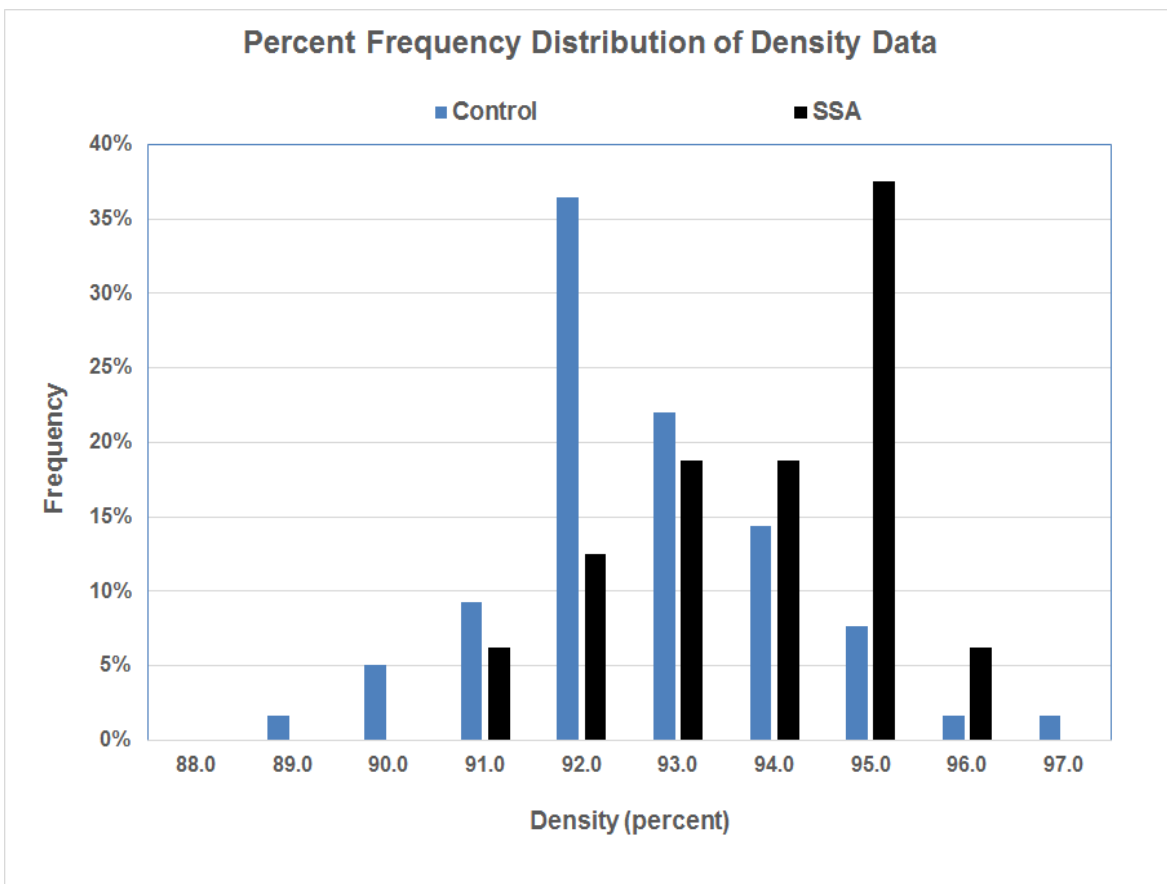
The average density of the SSA trial section was 1.3 percent higher than the average density of the control section. Figure 12 shows the percent frequency distribution of the control and SSA section density results. This illustrates the close grouping of the SSA section results in the 91-96 percent range and the more widespread distribution of the control section results in the 89-97 percent range. The densities were concentrated at 92 percent for the control section mix and at 95 percent for the SSA trial section mix.

Figure 12. Percent frequency distribution of density test results for control and SSA sections.

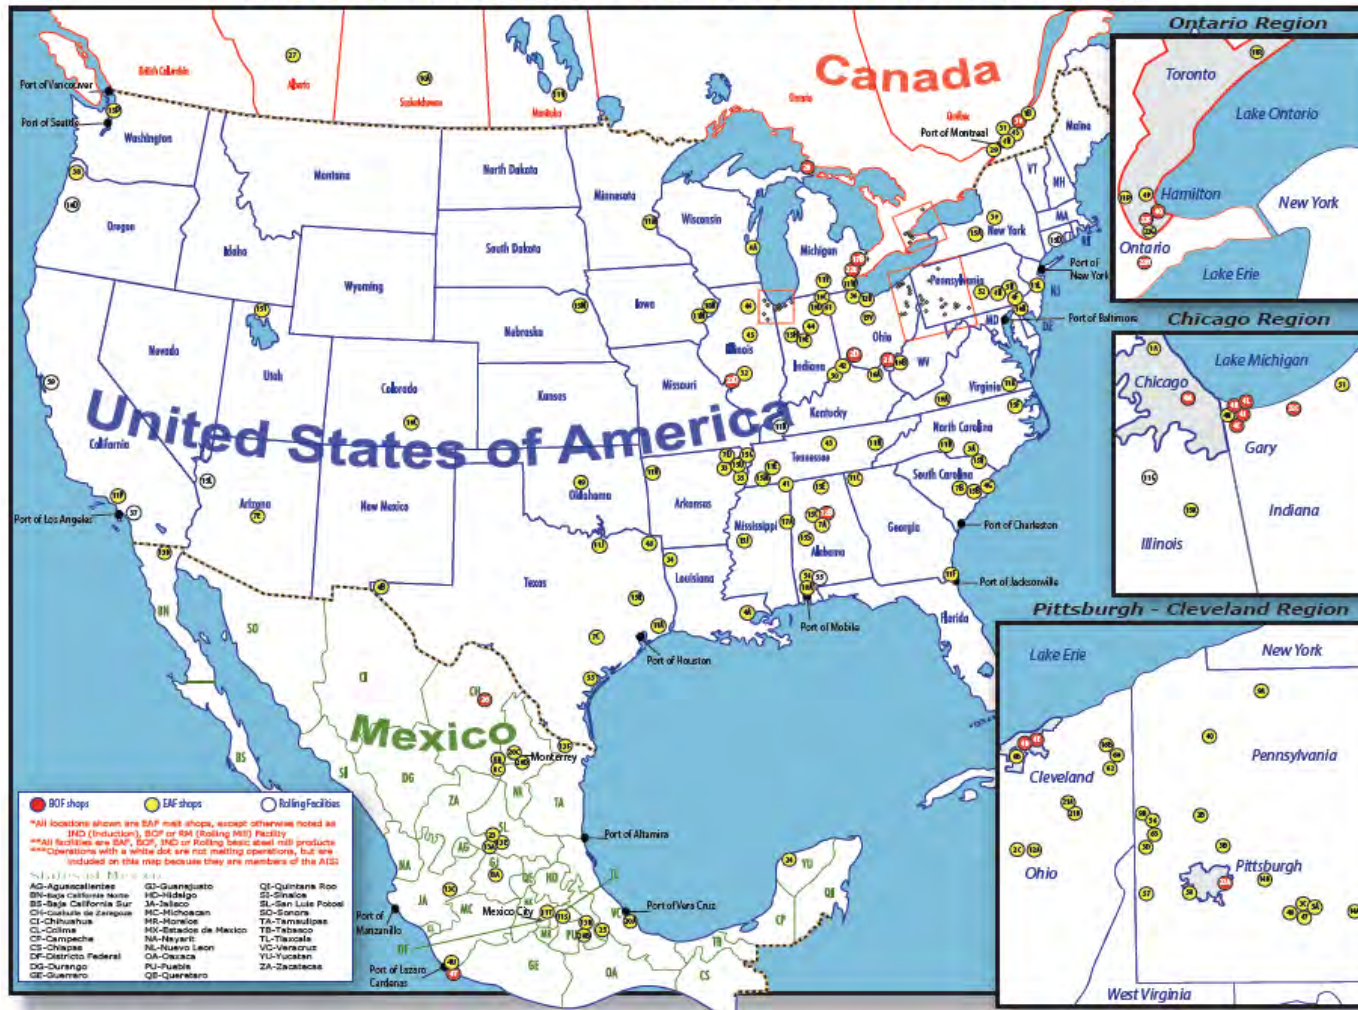
Figure 13. Location of steel plants in North America. (Courtesy of AIM Market Research, Pittsburg, PA)

Asphalt contractors in Washington as well as other states locate their asphalt plants at aggregate sources to minimize handling and to avoid a double haul of aggregate, once from the source to the asphalt plant and a second time when hauling HMA from the plant to the paving project. Figure 13 shows the location of steel plants in North America. The previously completed literature search on steel slag aggregate noted that Alabama, Colorado, Connecticut, Indiana, Illinois, Iowa, Kentucky, Minnesota, Missouri, Ohio, Oregon, Pennsylvania, South Carolina, Virginia, Wisconsin, and West Virginia have experimented with or used steel slag aggregate in asphalt pavements. It is evident from the map that states with SSA sources tend to be the ones that use or experiment with SSA in pavements due to their proximity to ample supplies of SSA.
